**CALIFORNIA DEPARTMENT OF CONSERVATION
DIVISION OF MINES AND GEOLOGY**

**FAULT EVALUATION REPORT FER-236
BARTLETT SPRINGS FAULT ZONE
LAKE AND MENDOCINO COUNTIES, CALIFORNIA**

by
William A. Bryant
Associate Geologist
December 9, 1993

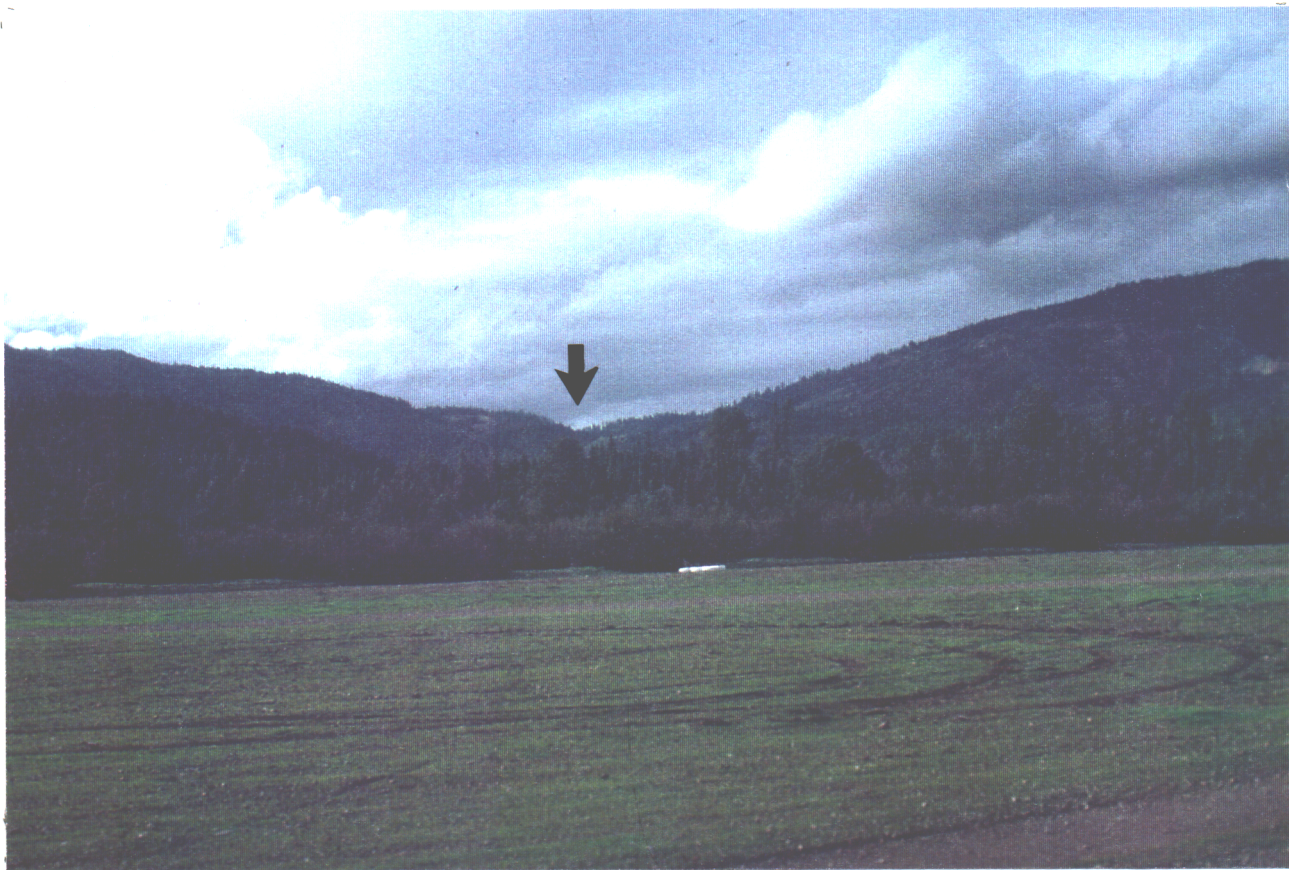
Photo 1 (to FER-236). The Bartlett Springs fault zone characteristically is located in a topographically low region generally coincident with a northwest-trending zone of Franciscan melange. This view to the northwest illustrates the location of the Coyote Rocks segment of the Bartlett Springs fault (arrow) in the Gravelly Flat area just north of Lake Pillsbury (refer to locality 18, Figure 3b).

dePolo and Ohlin reported that the Bartlett Springs fault zone can be divided into four principal segments from north to south: the Elk Creek fault (after CDWR, 1969); the Hot Springs shear zone (after Etter, 1979); the Chalk Mountain segment; and the Wilson fault (after Lawton, 1956). They stated that the Bartlett Springs fault zone occupies a topographic low nearly coincident with a narrow belt of Franciscan melange and ultramafic rocks (Photo 1), is up to 1.5 km wide, and is steeply dipping.

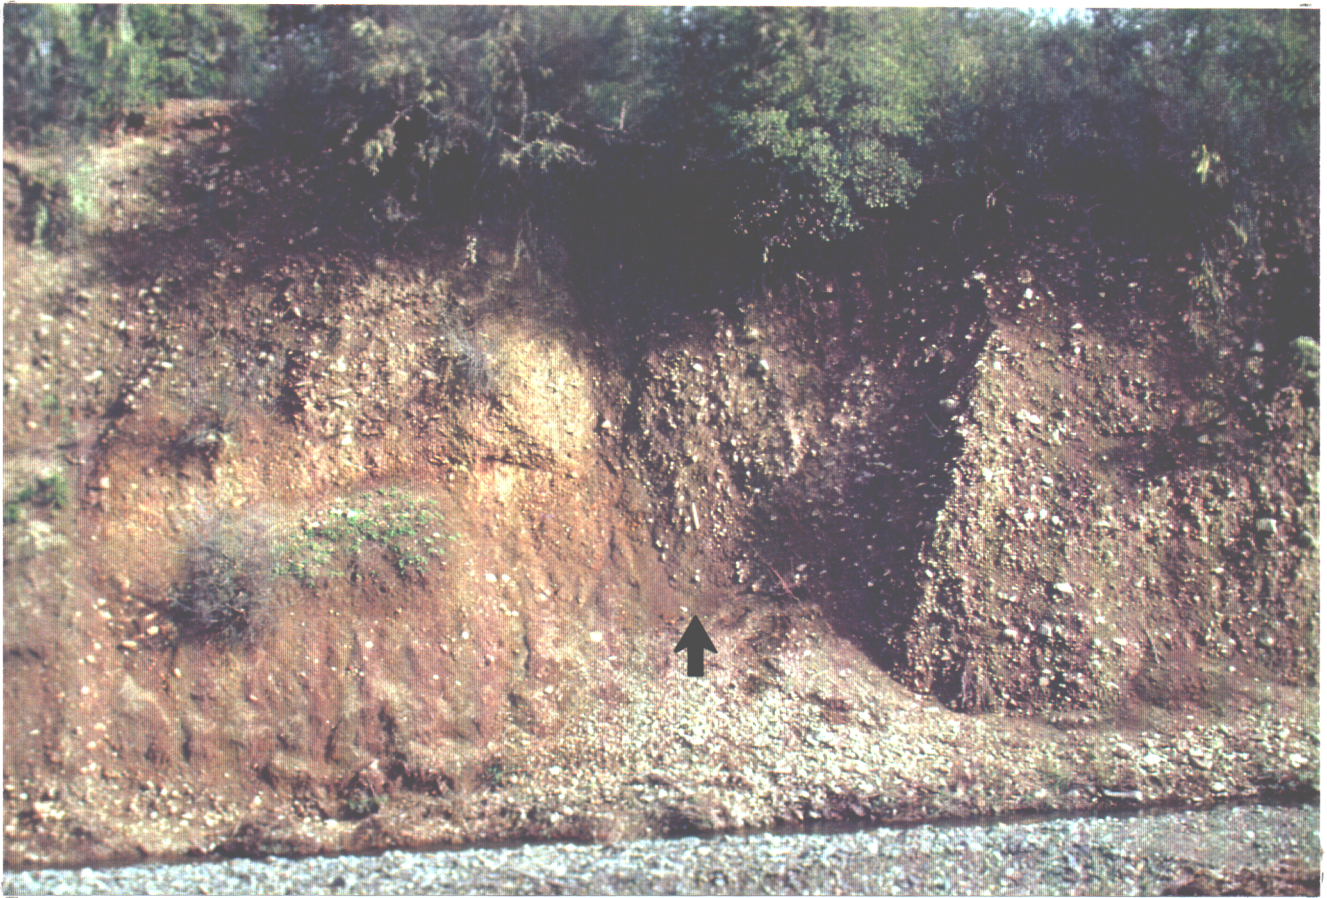
Photo 2 (to FER-236). View to the southeast of the Sunset Point lineament (Exposure B of Geomatrix, 1986). Late Pleistocene terrace deposits are vertically offset about 2.7 meters. The fault (arrow) is delineated by a disturbed zone of gravel with vertically oriented clasts. The southwest-facing scarp at this location is about 2.7 meters high. Refer to Figures 3b and 6 for location and log of Exposure B.

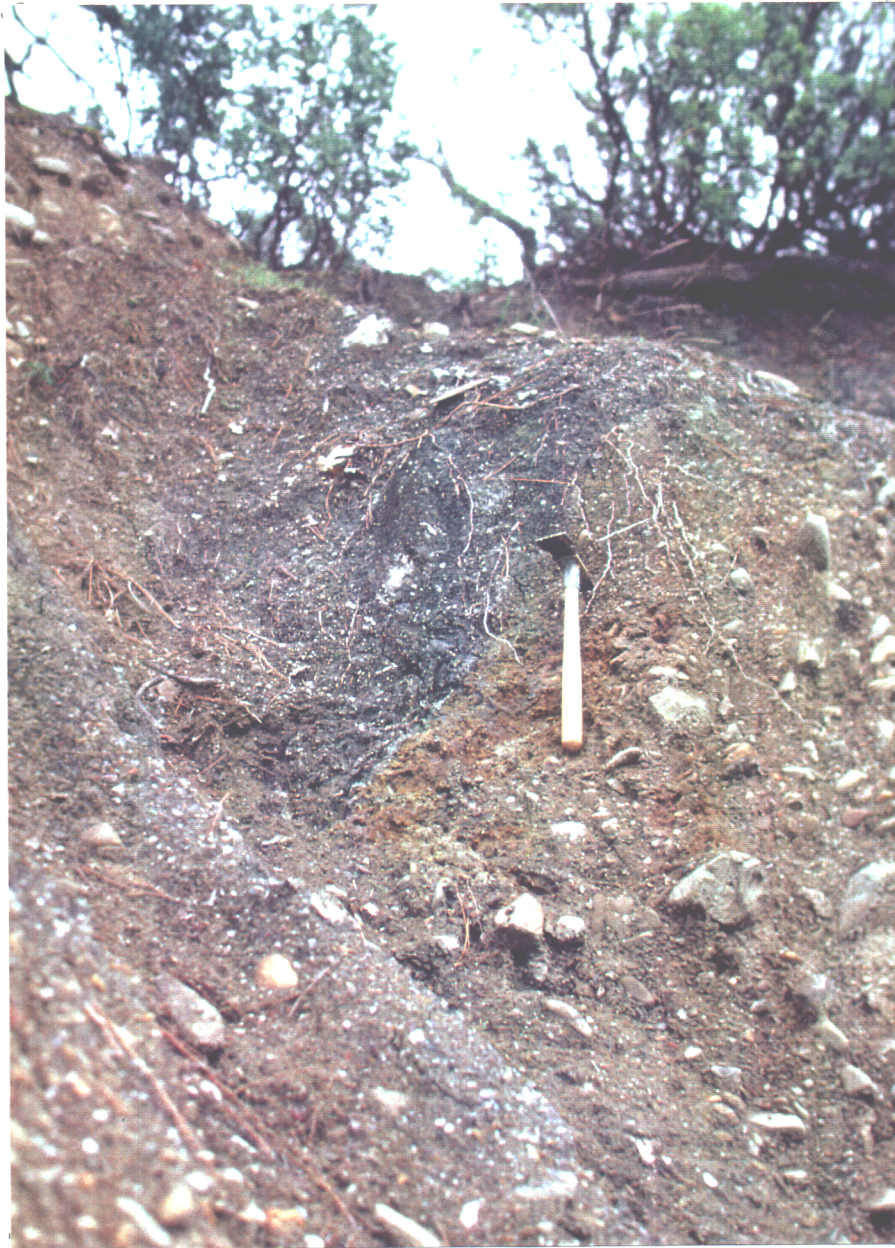
Photo 3 (to FER-236). Exposure of Coyote Rocks segment of Bartlett Springs fault near Exposure A of Geomatrix (1986). Fault offsets late Pleistocene terrace gravel against Holocene terrace deposits. Fault zone is delineated by serpentinite gouge (hammer).
